**FIVE-YEAR REVIEW REPORT FOR
NL INDUSTRIES/TARACORP LEAD SMELTER SUPERFUND SITE
Granite City, IL**

**U.S. Environmental Protection Agency
Region 5
Chicago, IL**

3/28/2014

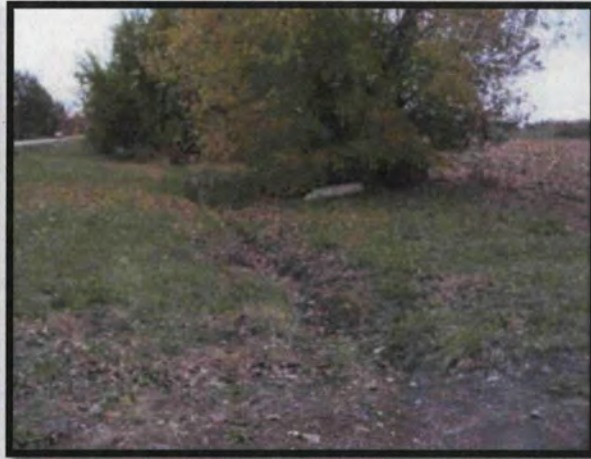
Photograph 2: Sand Road property.

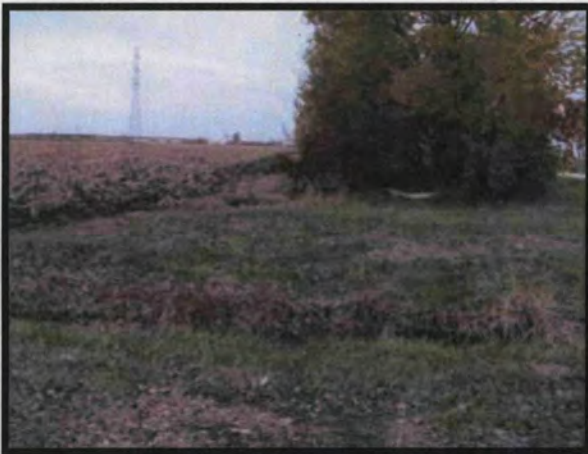
Photograph 3: Sand Road property.

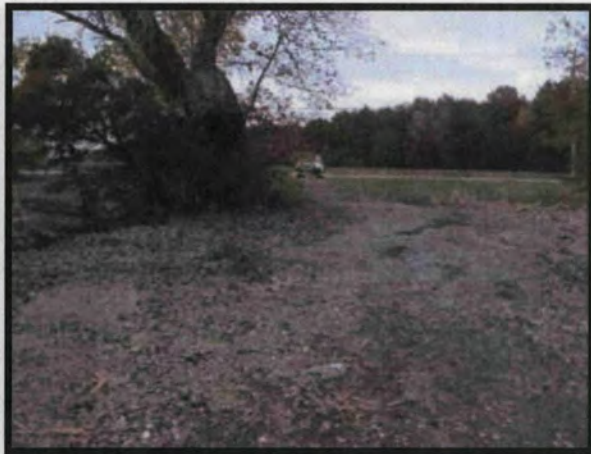
Photograph 4: Sand Road property.

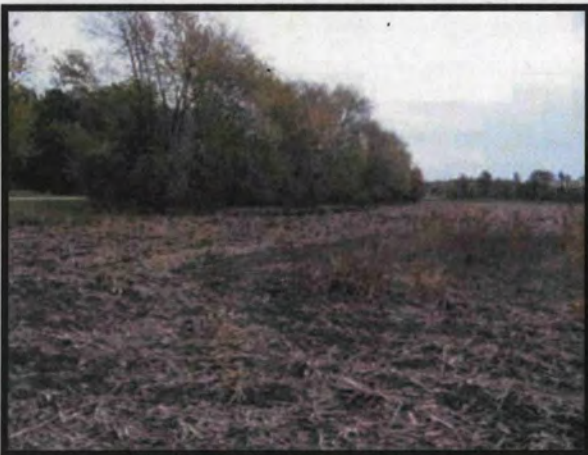
Photograph 5: Sand Road property.

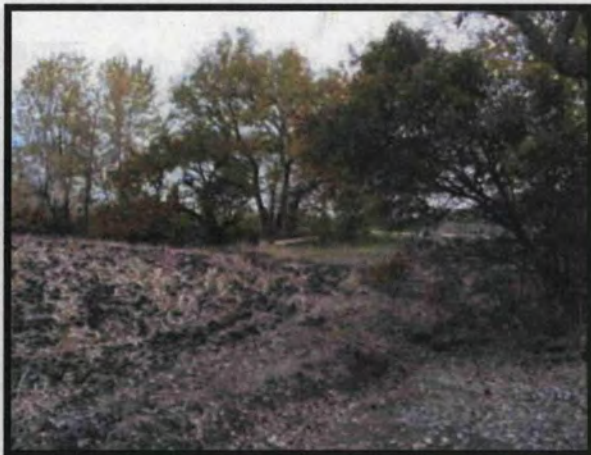
Photograph 6: Sand Road property.

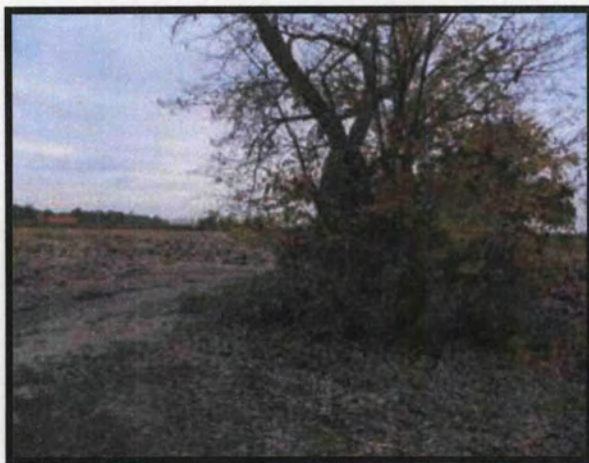
Photograph 7: Sand Road property.

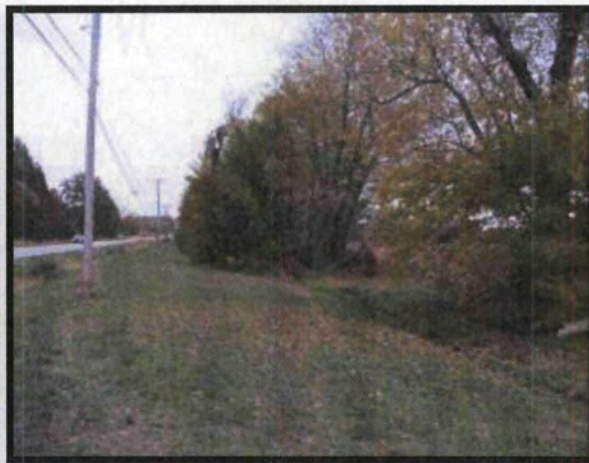
Photograph 8: Sand Road property.

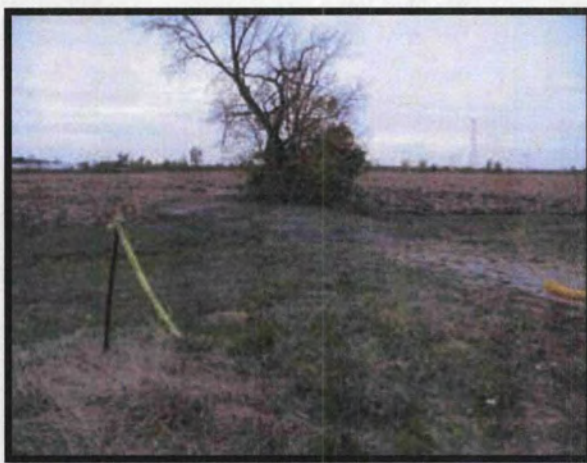
Photograph 9: Sand Road property.
